**PROPANE TRUCK COLLISION WITH  
BRIDGE COLUMN AND FIRE  
WHITE PLAINS, NEW YORK  
JULY 27, 1994**

**HIGHWAY ACCIDENT REPORT**

**Adopted: November 14, 1995  
Notation 6479A**

**NATIONAL  
TRANSPORTATION  
SAFETY BOARD**

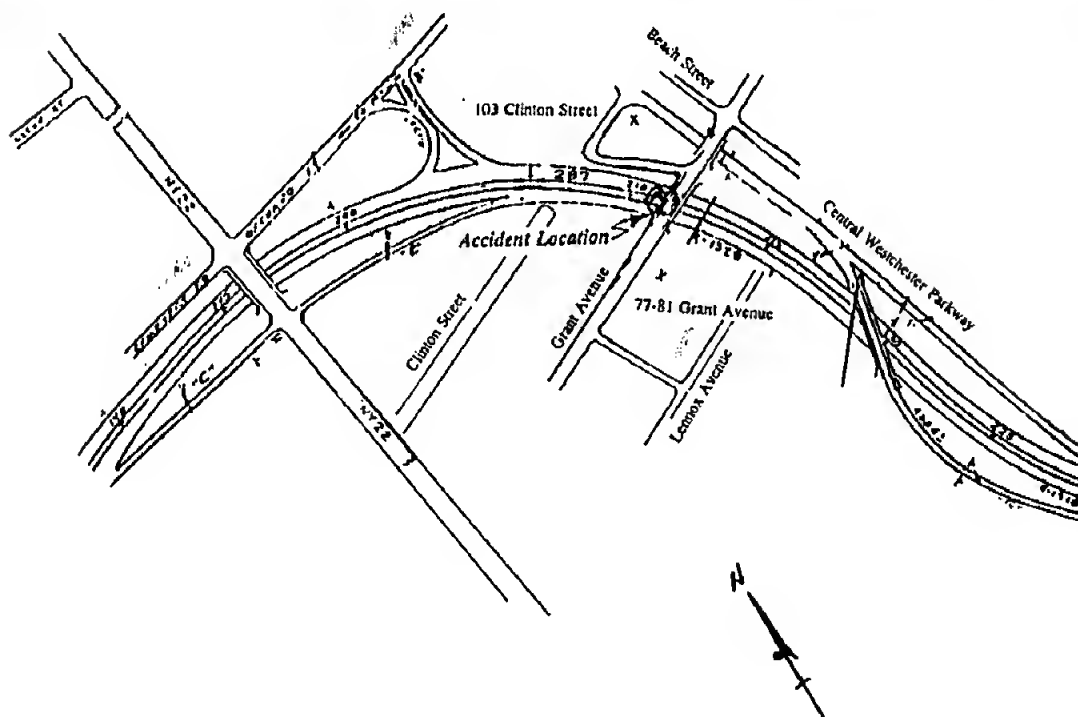
Figure 11. - Plan view of accident site

**Highway Description** -- The accident occurred on a 1,550-foot-radius (centerline radius) curve to the right on a 2.26-percent downgrade. (See figure 11.) The curve was 2,246 feet long and had 250-foot-long spiral transitions at each end. The centerline of the Grant Avenue bridge was 1,750 feet from the beginning of the curve. The bank or superelevation for the curve was +0.06 (percent). At the accident site the left shoulder slope was approximately -0.02 and the embankment foreslope approximately -0.16.

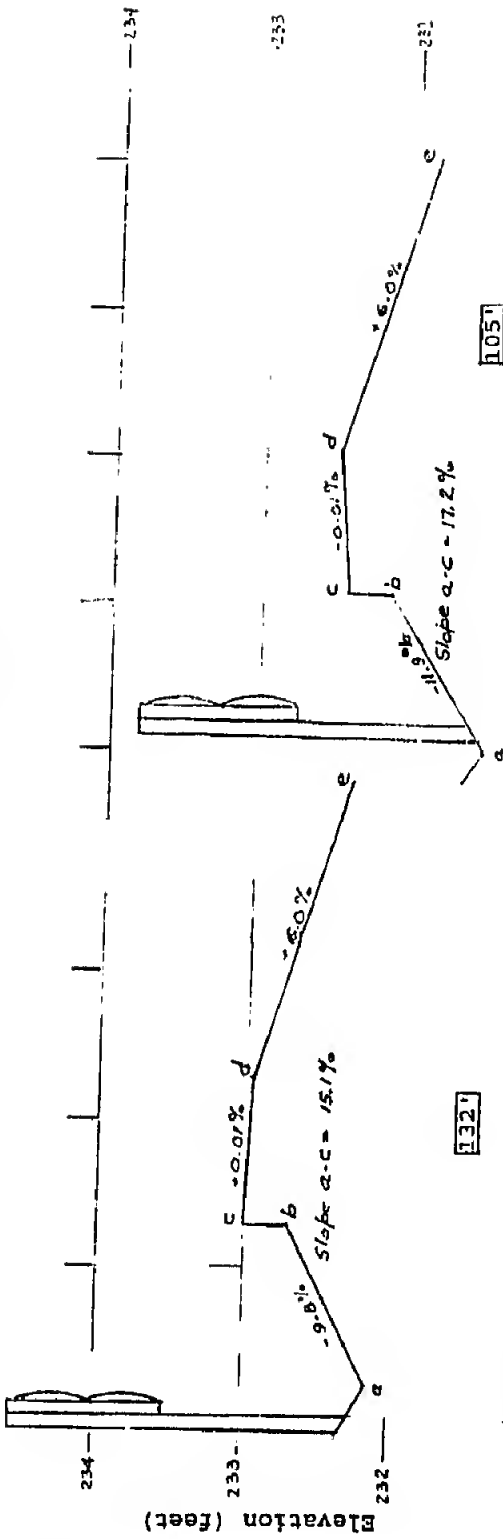
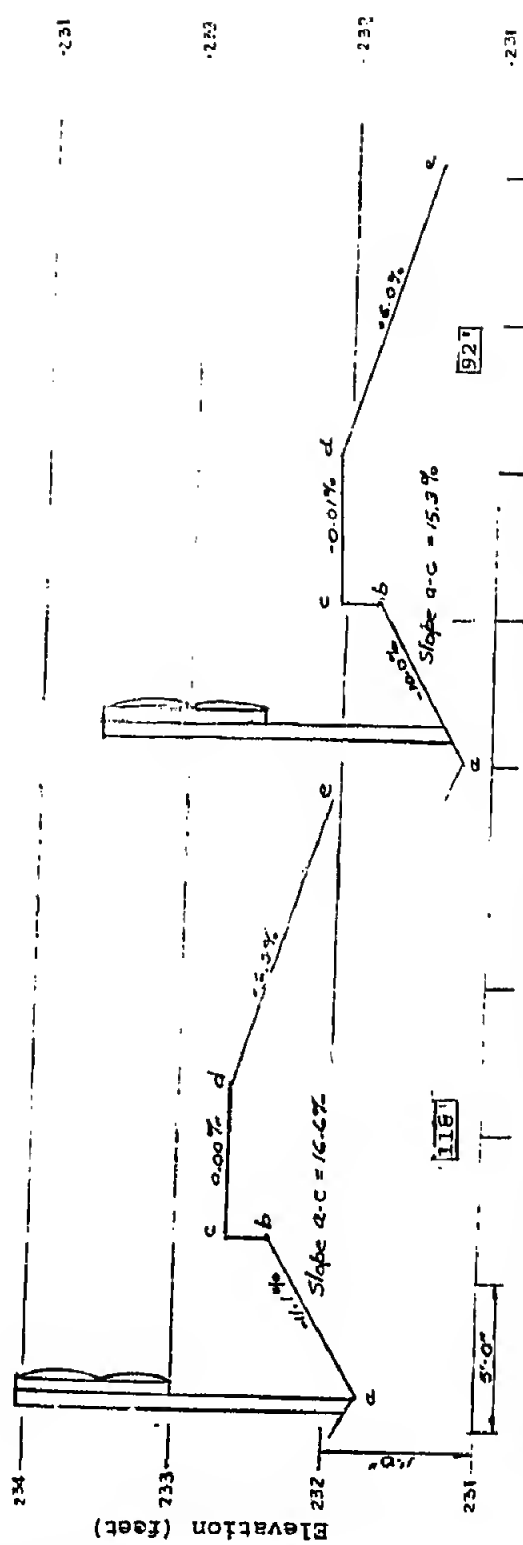
The following four diagrams show the derivation of the superelevation at four different locations on the roadway prior to the accident site. The elevations were determined from the survey made after the accident by CHAS H. SELLS, INC., of Bedford Hills, New York.

ab = ditch slope  
bc = shoulder drop off  
cd = traveled way
